Dissatisfaction with ABT Opti-Flow Burners in IGS Unit 2

Fwd: U2 Outage F Burner Inspection

>>> Aaron Nissen 10/15 8:45 PM >>> U2 Outage F Burner Inspection Summary

Reason- F3 Burner Fire (which resulted in the isolation of this new ABT burner)
When-Inspection conducted during U2 Boiler WW Tube Leak (on 2 1/2 floor) 10/12/2005
What-Removed burner elbows to inspect coal nozzles & tips and repair damage found
Inspection- Phil Hales & Aaron Nissen

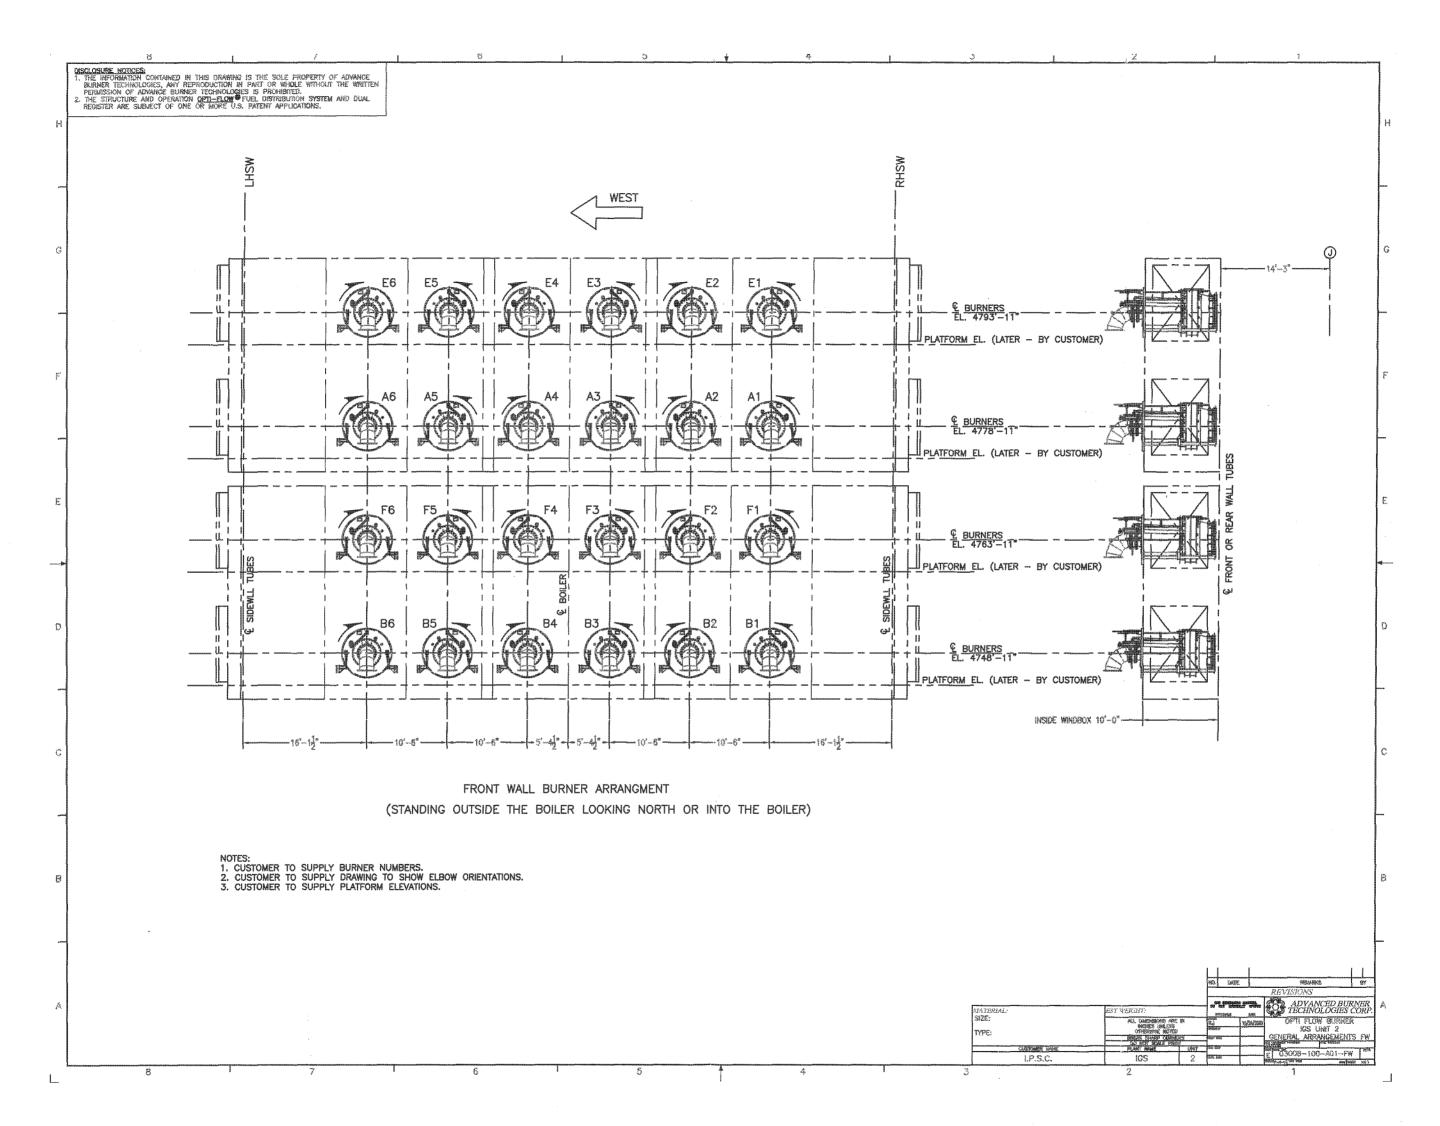
This erosion is within the first 18" of the nozzle. F6 nozzle, left side, had a hole eroded completely through.

Nozzle tips- major erosion and holes in the flowered tip (designed for coal staging), plus cracks in the "high tech alloy". Near impossible to weld up and due to high temps from furnace flame, impractical to RTV or nordbak/ceramic patch. Also the weld interface from the nozzle to the tip has creep damage (warped)

Coal Nozzles- ALL (except F3) coal nozzle sidewalls weld repaired at (3:00 & 9:00 clock position)
Coal Elbows- ALL (except F3) elbows were ceramic (nordbak) repaired at the very top (holes in ceramic)
F2 also had an external patch installed due to a hole in the 1st external patch
